University of British Columbia
Seismic Resilience Study
Seismic Risk Assessment and
Recommended Resilience Strategy

Issue 2 | Aug 11, 2017

Job number 248914

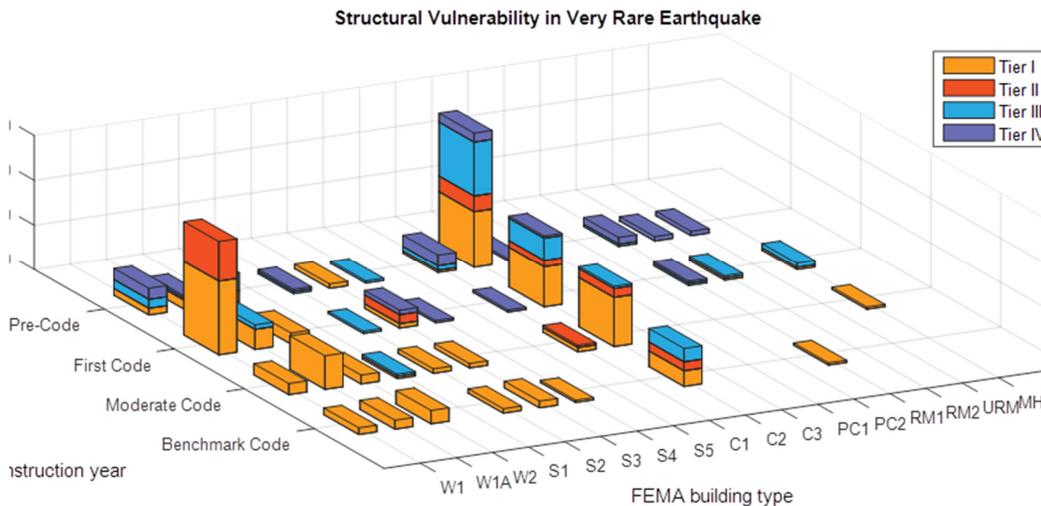
Figure 4 shows the assignment of Structural Vulnerability Tiers by the type of building construction and the building code used for the design of the building. As expected, buildings designed prior to the building code or to the first iteration of the building code are more collapse prone.

Figure 4 Structural Vulnerability Tier assignments by building code and construction type. W = wood, S = steel, C = concrete, RM = reinforced masonry, URM = unreinforced masonry, MH = manufactured housing

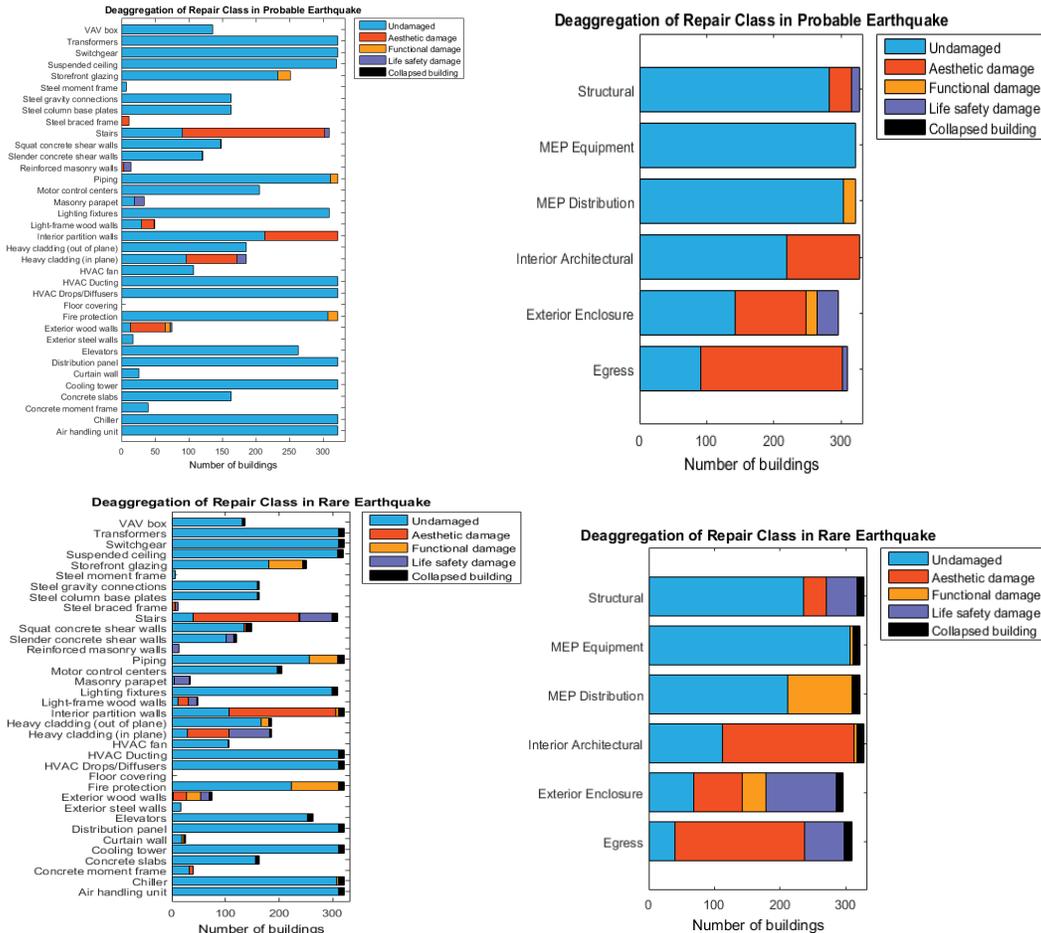
In addition to the components highlighted above and in Figure 5 **Error! Reference source not found.**, the impact of non-structural components and contents on business continuity are discussed in more detail in Appendix K. Conceptual mitigation measures are also described.

Figure 5 Inventory of building components which trigger downtime (yellow = damage hindering functionality, purple = damage hindering re-occupancy and functionality) in Probable (top) and Rare (bottom) level shaking

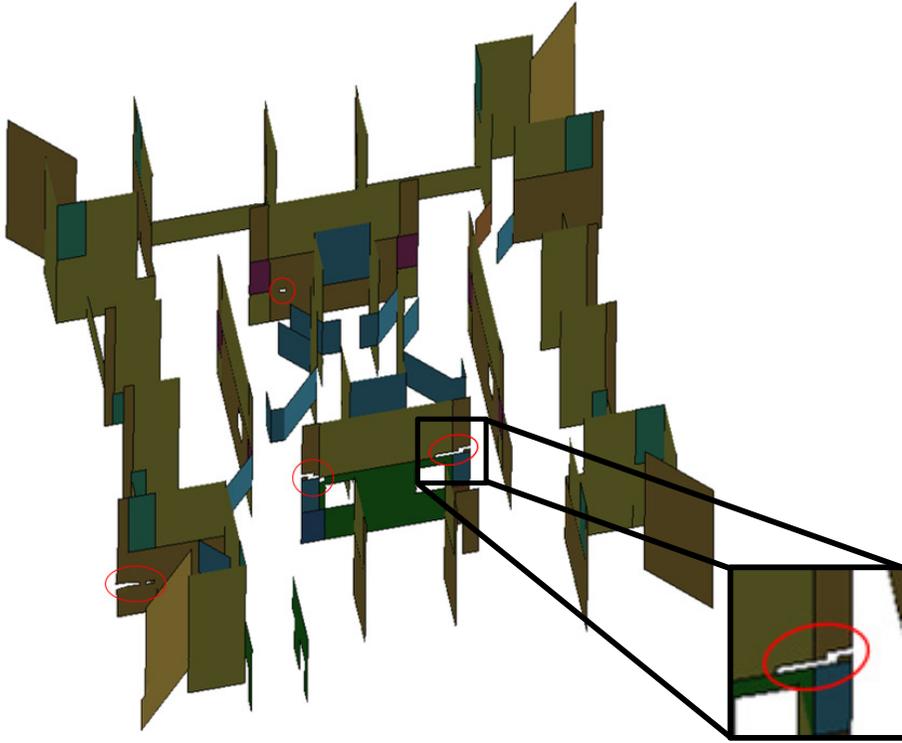
Figure 7 Failed (deleted) elements at end of Very Rare Subduction GM7, representing portions of wall which have seen concrete crushing through the whole section and rebar buckling. Failed areas circled in red. Only walls at first three levels shown.

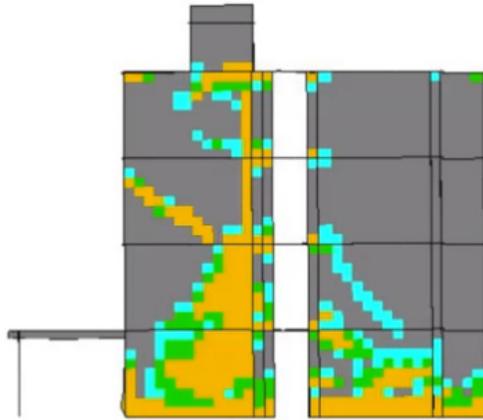
Figure 8 Crack pattern for Place Vanier at end of Very Rare ground motion (yellow = rebar yielding, but not rupture).

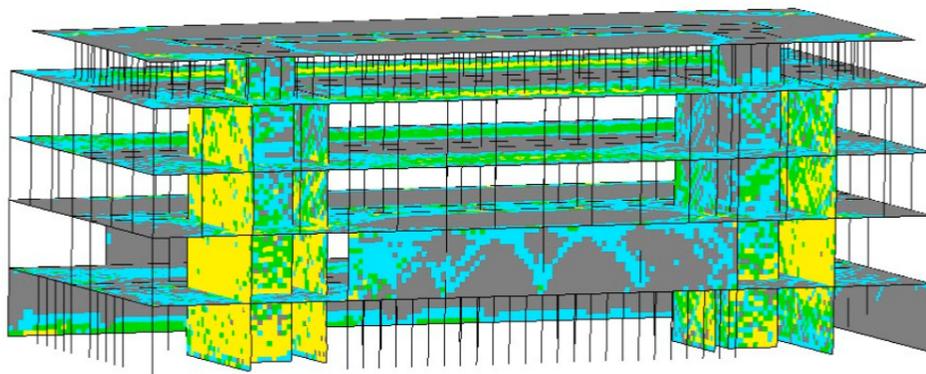
Figure 9 Crack pattern for Lasserre at end of Very Rare ground motion (yellow = rebar yielding, but not rupture).
