University of British Columbia
Seismic Resilience Study
Seismic Risk Assessment and
Recommended Resilience Strategy

Issue 2 | Aug 11, 2017

Job number 248914

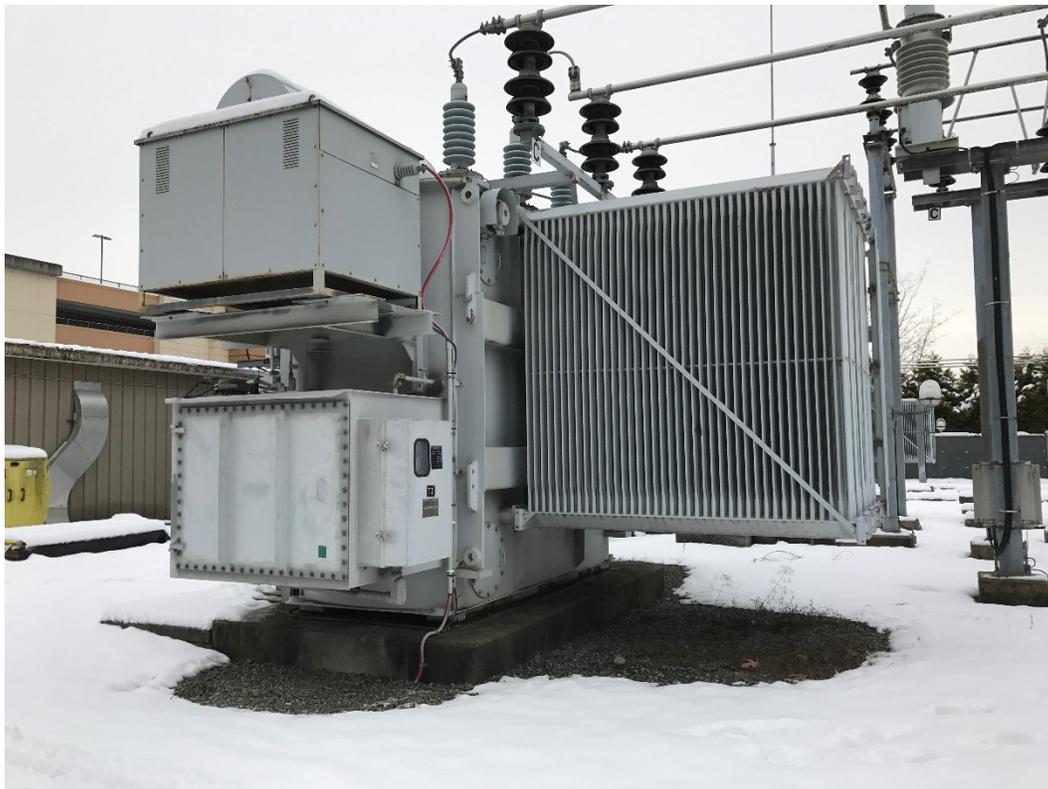
In terms of equipment, there are two 46.7 MVA transformers in the main substation yard (see Figure L.2). Given current campus energy demands, one transformer can power the entire campus, meaning there is redundancy in the system if one were to fail or needed to be serviced. The transformers were installed in 1983 and have a typical operating life of 30-40 years, but are expected to have a longer service life due to their light operating load. The transformers are anchored to a concrete pad; however, we were unable to observe anchorage details because the transformers were in operation. If one of the transformers were damaged in an earthquake, it is unlikely that it could be fixed onsite by campus staff. Staff anticipate it could take 6-24 months to service a damaged transformer, and \$1-2 million CAD to replace.

Figure L.2 One of the two 46.7 MVA transformer at the main campus substation

- Important electrical equipment at the main substation, including the two 46.7 MVA transformers in the yard and switchgear in the substation building, were installed 30-40 years ago, meaning they are not likely to be seismically qualified. Therefore, they could be more vulnerable to damage in an earthquake than newer equipment. Furthermore, the anchorage of electrical equipment was likely upgraded to satisfy the 1995 National Building Code of Canada; however, anchorage requirements have changed significantly since then. Consequently, the electrical equipment is more vulnerable to anchorage failure and toppling than newer equipment. This is especially important given the long lead times in repairing and/or replacing equipment.

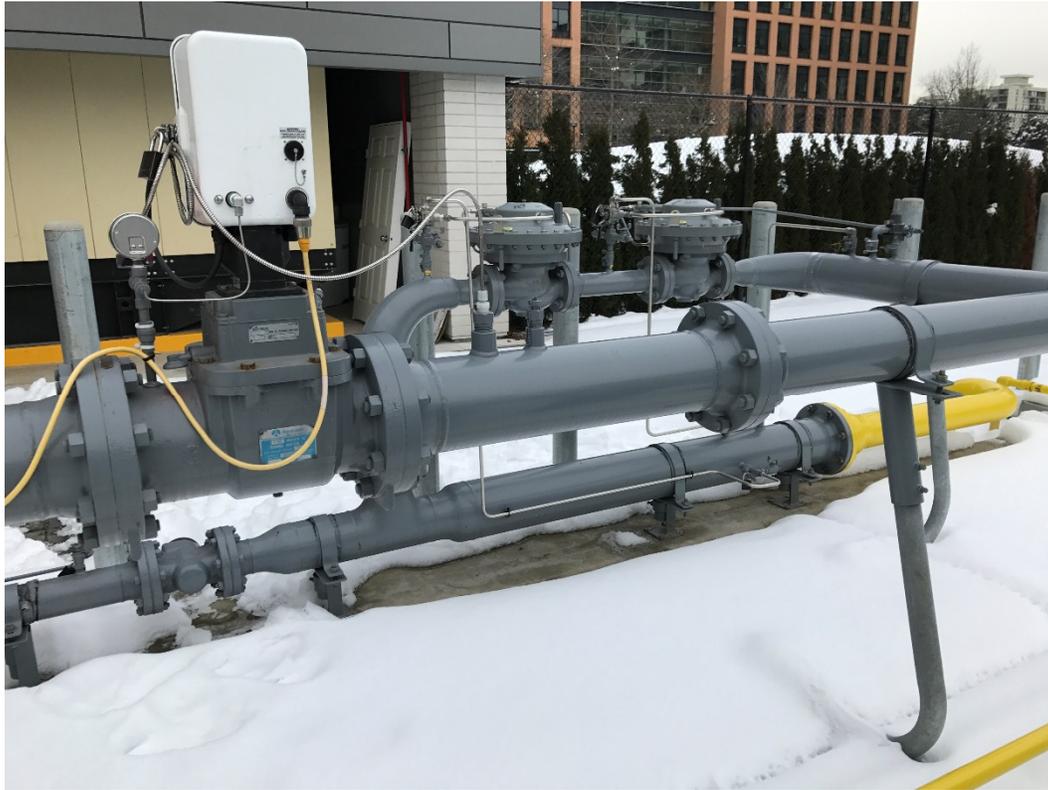
There are four pressure reducing stations on campus, including one adjacent to the Power House that handles 50% of UBC's gas supply and one outside the Campus Energy Centre (see Figure L.5). These stations on campus are outdoors and consist of a series of pipes, valves, gauges, and regulators that reduce the incoming transmission line pressure from 100 to 15 PSIG for distribution purposes. These stations do not depend on electricity to remain functional and have proven in recent earthquakes to be rugged.

Figure L.5 Pressure reducing station at the Campus Energy Centre

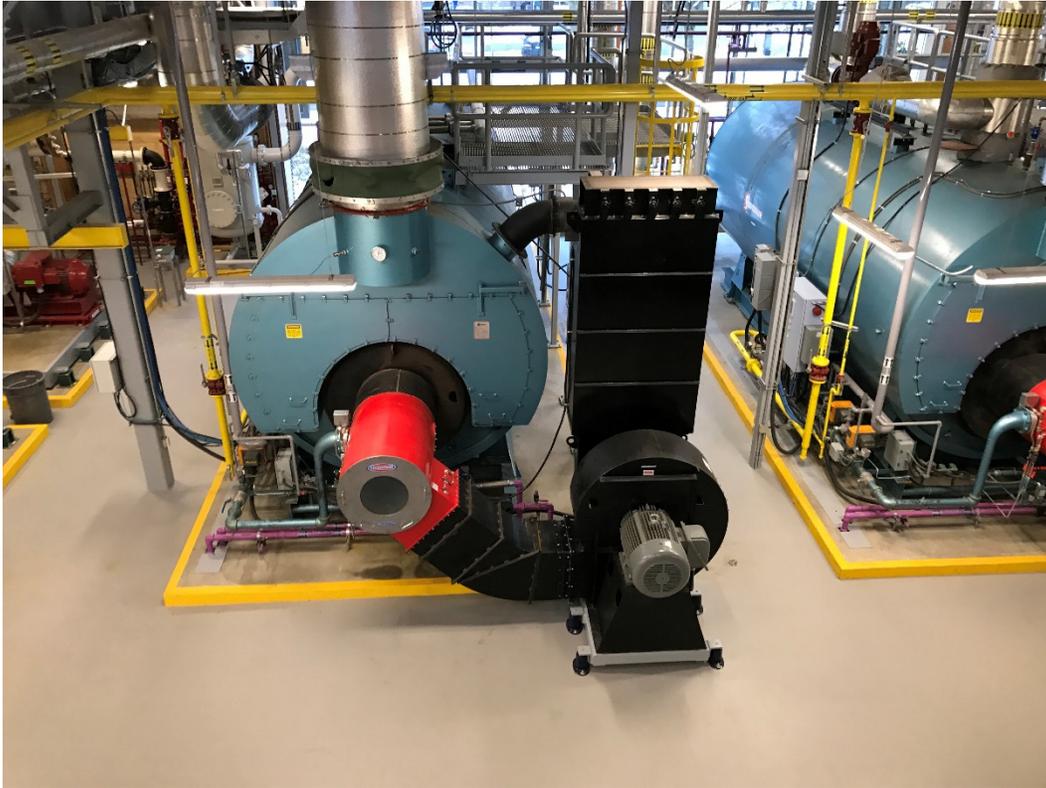
Currently there are three 15 MW boilers on the ground floor of the CEC that heat water, with space to install a fourth to accommodate future campus needs (see Figure L.7). Because of the interruptible gas supply, the boilers are dual fuel, meaning they can be powered by either natural gas during normal operation or diesel fuel if natural gas is unavailable. Anchorage for the boilers and all equipment at the CEC has been designed for seismic forces; however, not all anchorage was readily visible during inspection and not all equipment anchorage was thoroughly inspected. In general, all new equipment installed on campus has anchorage designed for seismic forces, while equipment installed prior to 1970 is likely to be unanchored.

Figure L.7 15 MW boilers at the Campus Energy Centre

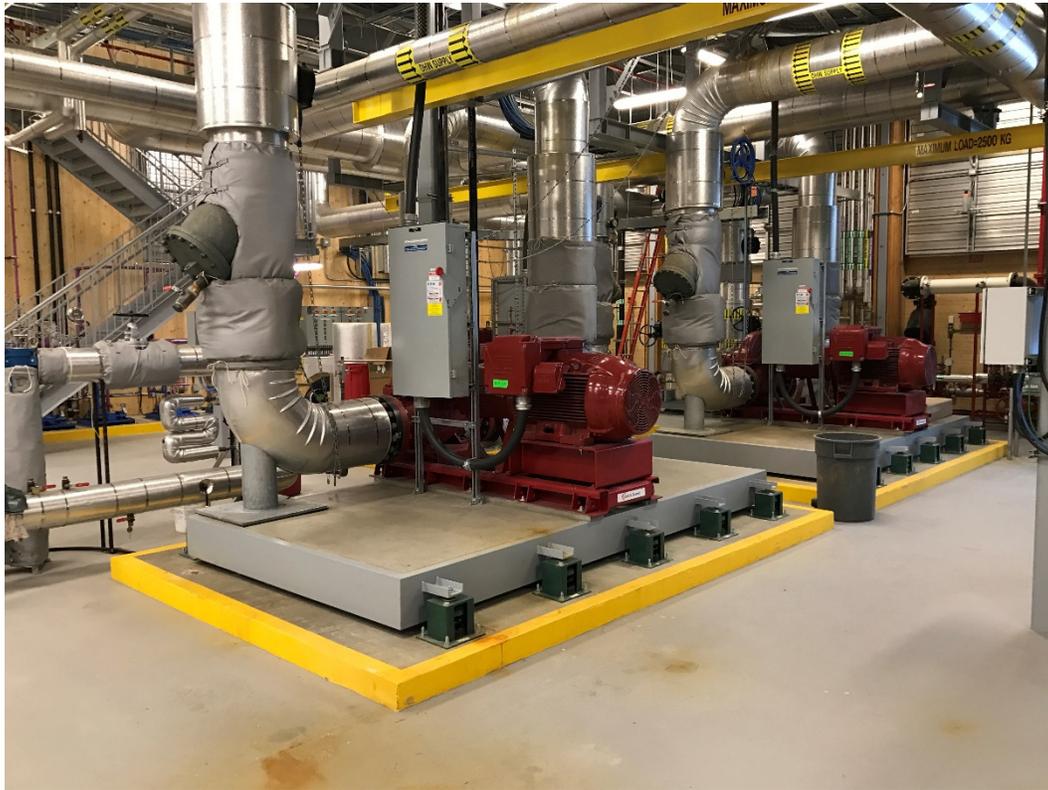
There are three electric distribution pumps adjacent to the boilers that provide the pressure necessary to deliver hot water to individual buildings (see Figure L.8). These distribution pumps do not need water for cooling. Typically only two pumps are running at any given time, one at 100% and the second at 50%, so there is redundancy in the system if a single pump failed. The pumps are anchored to a concrete pad that is vertically isolated from the ground floor. Drawings indicate that pipe connections to/from the distribution pumps (and also the boilers) are flexibly detailed. However, the pumps (and other equipment) have not been seismically qualified, meaning that their internal components could be damaged by strong earthquake shaking.

Figure L.8 Distribution pumps at the Campus Energy Centre

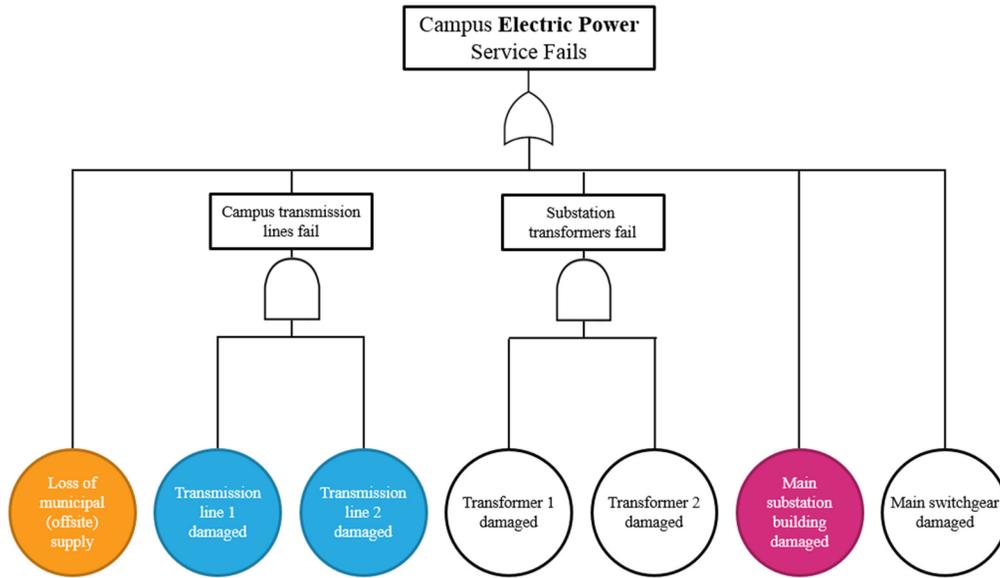
Figure L.12 Electric power supply system fault tree

The campus electric power supply system fault tree is shown below in Figure L.12. Single point failures include loss of municipal electric power supply, damage to the main substation, and the main switchgear. In a very rare earthquake, the median disruption time for the municipal supply is 7 days, as shown in Table L.3. The main substation building is not expected to sustain significant damage in a very rare earthquake and the components inside should not cause disruption to the campus electric power supply. Damage to the main switchgear can lead to an average downtime of 20 days for the entire supply system.

Transformers have an especially high restoration time. If there is damage to the transformer itself, it can take more than six months to repair/replace the equipment as it may have to be shipped out for servicing. This kind of damage is expected to occur at very high peak ground acceleration values, if the equipment is well-anchored. However, our analysis did not explicitly include the correlation between the transformers. If they are identical and co-located, there is some probability that if one of them were to fail, the other would fail as well.

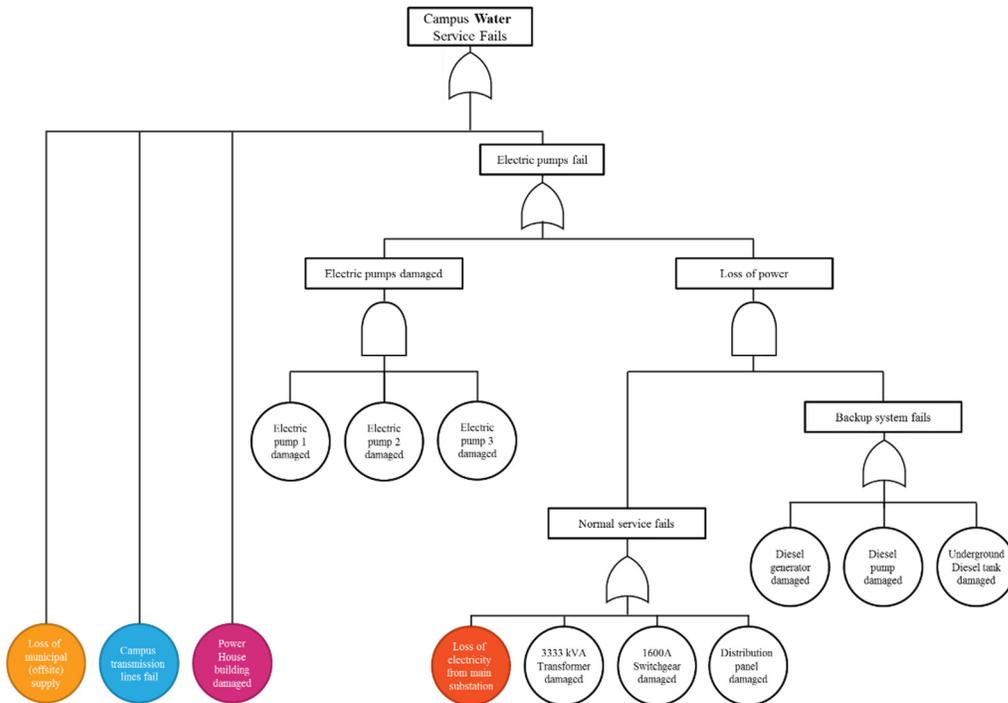
Figure L.13 Water supply system fault tree

The Power House building is a vulnerable building, and access to it is crucial in restoring water service on campus, as many of the equipment that operate as part of the water supply system are contained within the Power House. As such, the model assumes that if the building PSRA results show a nonzero re-occupancy time, then UBC would devise a temporary workaround to restore water service as soon as possible, without relying on demolition of the facility and/or construction of a new facility. Thus, if the PSRA predicts nonzero re-occupancy time, the restoration time for the Power House is calculated using a lognormal distribution with a median of 60 days and a dispersion value of 0.5.

The campus transmission line consists of 800 meters of large-diameter welded steel piping, which is one of the more rugged and ductile materials. It is not expected that the transmission line would sustain significant damage and add to water supply downtime.

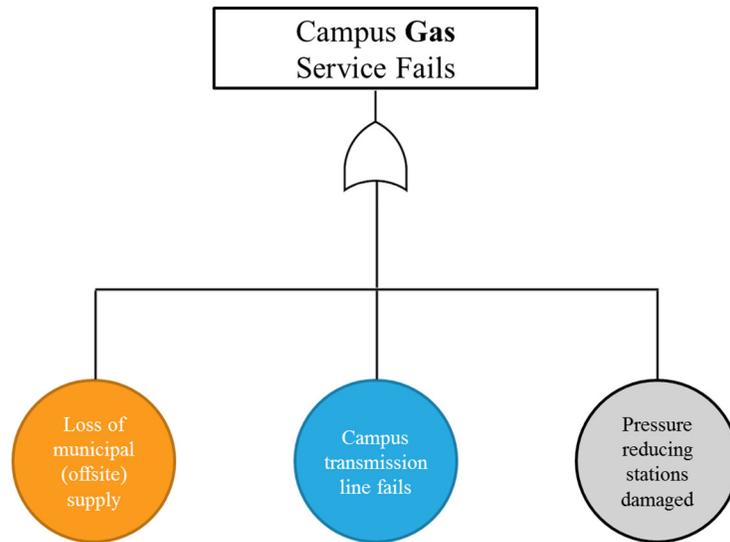
Figure L.14 Campus gas supply system fault tree

Figure L.14 shows the fault tree diagram for the campus gas supply system. The loss of municipal supply and damage to the campus transmission line govern the availability of natural gas service on campus. While pressure reducing stations play a role in providing natural gas service, they are not typically vulnerable components in earthquakes (EERI, 2014) and thus are neglected in the analysis.

The campus gas transmission line is a small-diameter welded steel pipe, 800 meters in length. Due to the ductility of the material and the relatively short pipe length, the transmission is not expected to sustain significant damage during a very rare earthquake.

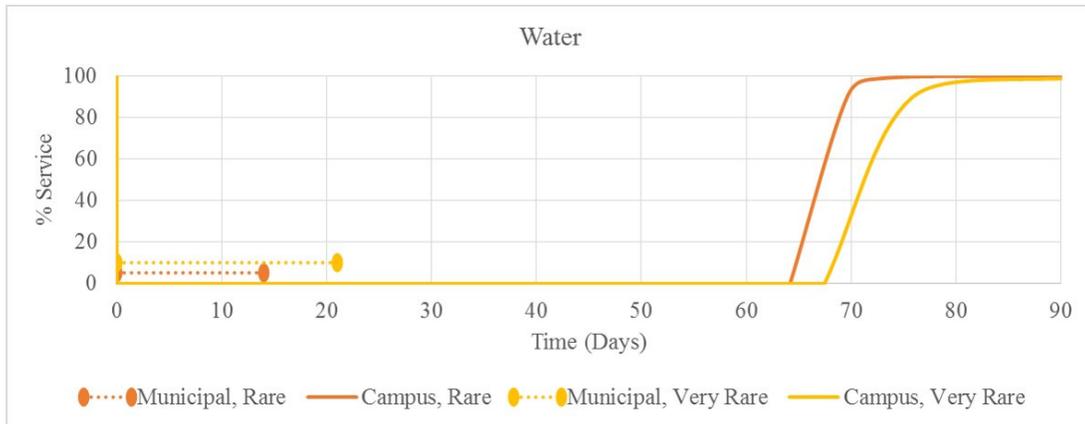
Figure L.19 Restoration curves for the water system (rare and very rare earthquakes)

Disruption to the water supply is dominated by the poor earthquake performance of the Power House building, in the probable, rare, and very rare earthquakes. The Power House has a high probability of collapse in rare and very rare earthquakes and has a high probability of being red-tagged in a probable earthquake. In these scenarios, we assume that water will be restored before the Power House is rebuilt, by UBC taking extraordinary measures to re-locate the water supply lines and pumps to an alternate location. We assume that this will take roughly 60 days for the purposes of the risk assessment. The Power House is the key vulnerability in the entire utility network.

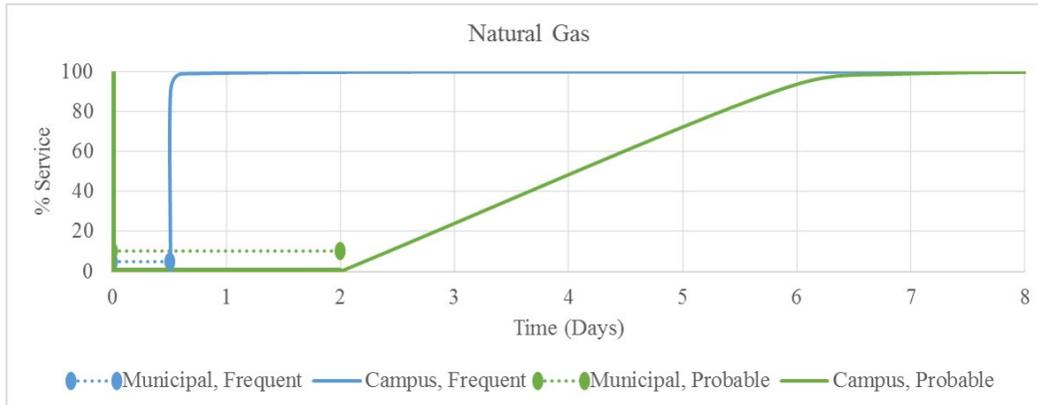
Figure L.20 Restoration curves for the natural gas system (frequent and probable earthquakes)

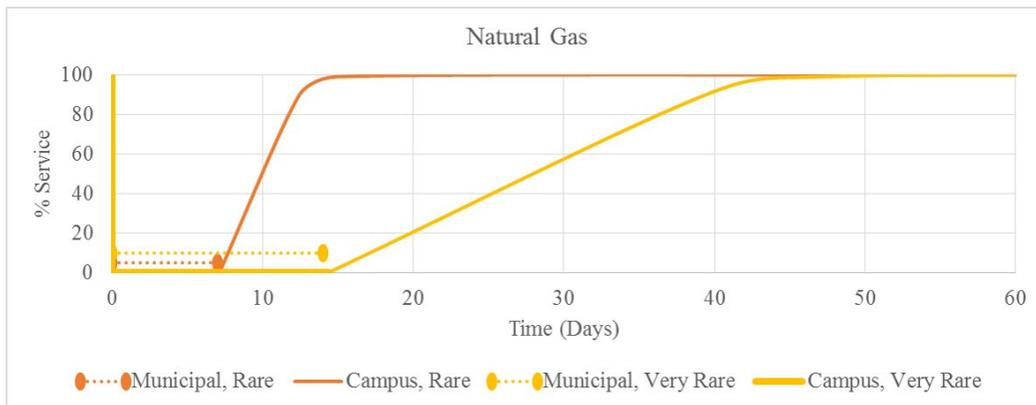
Figure L.21 Restoration curves for the natural gas system (rare and very rare earthquakes)

Natural gas is disrupted in rare and less intense earthquake shaking by the municipal supply. In very rare earthquake shaking, the shutoff valves are likely to be triggered. A major contributor to natural gas service recovery is re-lighting and re-pressurizing the distribution system which is anticipated to take a significant amount of time (hence the gradual curve towards 90% service recovery). An effective mitigation measure would be to implement operational preparedness measures that dedicate more manpower to priority buildings for re-lighting after an earthquake, particularly for sensitive research specimens that require constant access to natural gas supply.

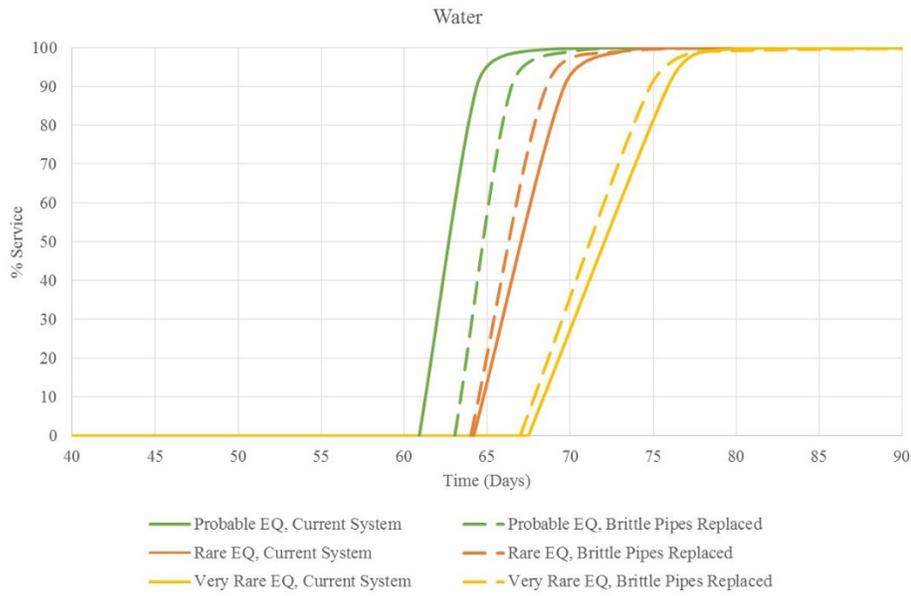
Figure L.22 shows the water service restoration curves before and after replacing the brittle pipes in the distribution system. Although the total service disruption time remains the same, the rate of recovery to 90% service is faster for the system with only ductile piping. Table L.17 presents the best estimate of number of water distribution pipe breaks for the four earthquake scenarios being considered, as well as the 90th percentile estimate of breaks. A brittle pipe replacement program would reduce the time to 90% service recovery by only one day, as it would reduce the best estimate of number of breaks by 1 and each break has an expected restoration time of 1 day. In summary, our analysis demonstrates that it may not be cost-effective to replace the brittle pipe, at least from a seismic perspective.

Figure L.22 Restoration curves of the water system before and after the brittle pipe replacement

The water distribution pipelines are composed of either cast iron or ductile iron. The former is a brittle material and has a higher probability of breaking in a seismic event. This section describes the results of modeling a water distribution system with all of the cast iron piping replaced with ductile iron piping.

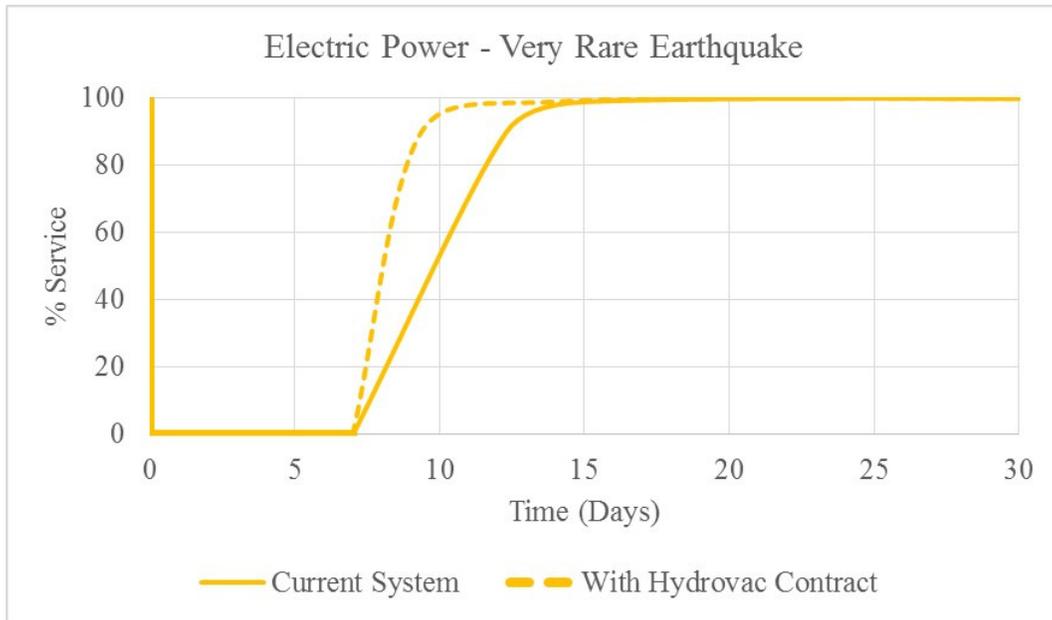
Figure L.22, Figure L.23, and Figure L.24 show the restoration curves of electric power, water, and natural gas with and without the hydrovac retainer contract. The restoration curves consistently reach 90% service recovery approximately two days earlier with the hydrovac retainer contract in place. Only the earthquake scenarios in which there is at least one underground pipe break are shown in the following figures.

Figure L.22 Electric Power system - restoration curve comparison for the very rare earthquake scenario

If UBC were to establish a retainer contract with a local company and guarantee that a hydrovac could be acquired within 1 day after a seismic event, the time estimated for distribution pipe repairs would decrease significantly. Relative to the estimated municipal supply outages, the estimated time to repair pipes is not significant. However, if the municipal supply happens to perform well, the restoration of piping would be critical path and the hydrovac appears to be an attractive option.

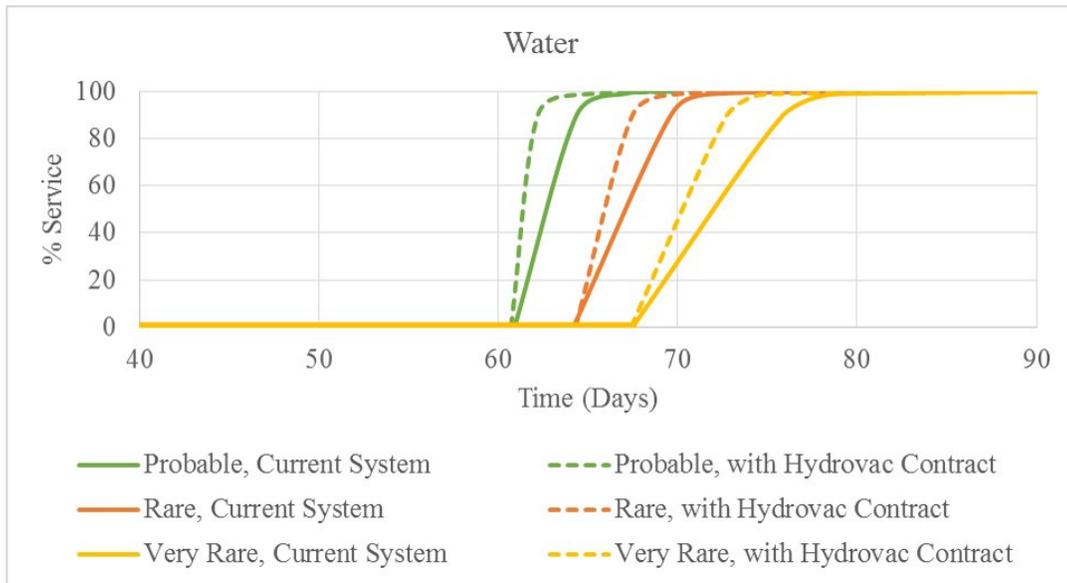
Figure L.23 Water system - restoration curve comparisons for the probable, rare, and very rare earthquake scenarios

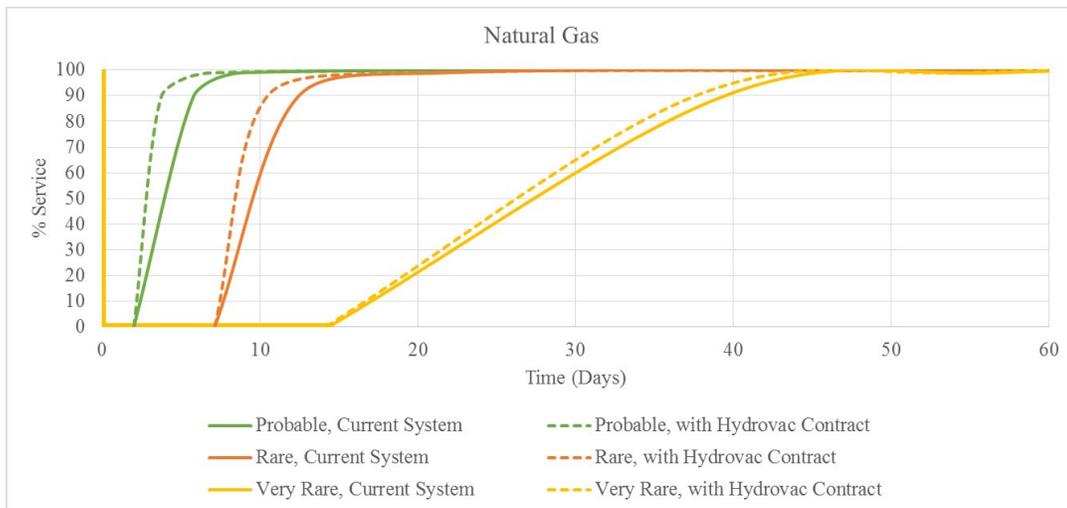
Figure L.24 Natural gas system - restoration curve comparisons for the probable, rare, and very rare earthquake scenarios

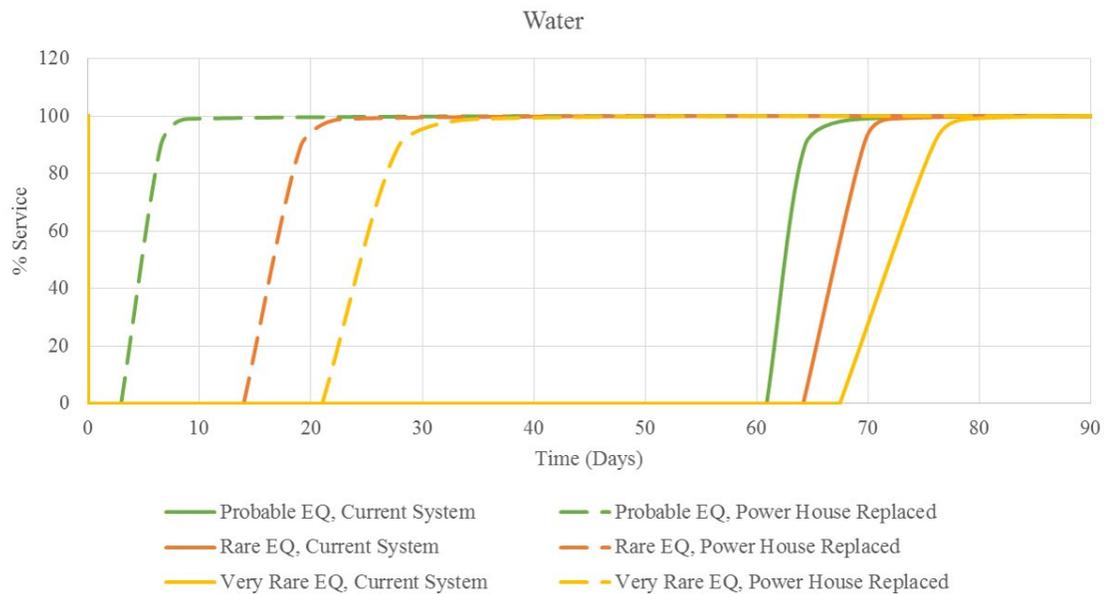
A key contributor to water disruption is the Power House facility that houses the water pumps. In all earthquake scenarios greater than the frequent intensity level, there is at least a 50% probability of the Power House being demolished, collapsed, or otherwise red-tagged (not safe for entry). In these scenarios, the water pumps and piping within the Power House are likely to be damaged and inaccessible for repairs. We assume it would take at least two months to install temporary mitigation measures to allow for water service on campus. Replacing the Power House with a new building or shelter for the water pumps—one that would perform in a capacity similar to the Campus Energy Centre in a seismic event—would greatly reduce the downtime associated with the water supply system and remove the single greatest vulnerability on the campus.

Figure L.25 shows the expected restoration curves for the current water system configuration, as well as the expected restoration curves for the water system after replacing the Power House.

Figure L.25 Comparison of water service restoration curves with the current system and with the Power House building replaced

Replacing the Power House with a building that has a low probability of collapsing or sustaining significant structural damage in an earthquake dramatically reduces the estimated time of total service disruption. Thus, this action is expected to be a worthwhile investment to prevent long-term outage of water service on campus.
